Surge Arrester Faults and Their Causes at EThekwini Electricity

M. Gumede and G. Frederick d’Almaine

Durban University of Technology/Power Engineering, Durban, South Africa

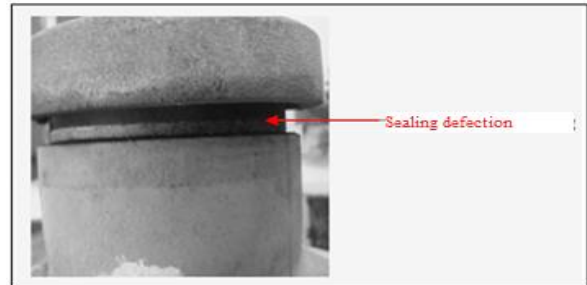
Figure 4. Upper sealing deflection.

The looseness of the insulation from the end sealing as represented in Fig. 4 [2], where for a surge arrester in-service the humidity inside can increase due to

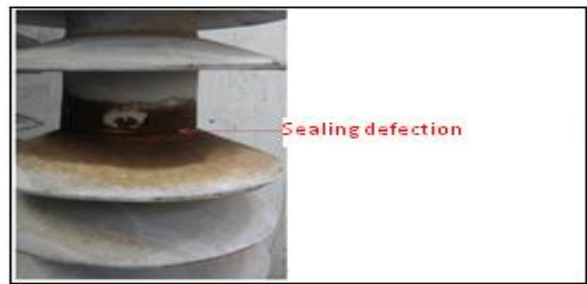
A defective arrester may not be able to work in a satisfactory way when an electrical surge occurs [9]. Hence, it could allow moisture to penetrate to a surge arrester housing or sealing (see Fig. 4 and Fig. 5). A consequence of this effect is the reduction of the level of security in the performance of the apparatus. As it has a continuous leakage of gases, the system of protection against explosion becomes inefficient, being no longer capable of performing on extreme heating [5].

Figure 5. Sealing collar defective [14].

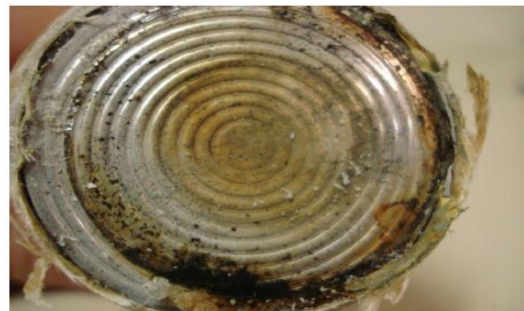
Moisture ingress in high voltage apparatus is the primary source of degradation [2] and [5], because of this situation several studies and research have been done in order to improve sealing material of arresters [10]. Earlier publications have showed that multistress aging testing is an important design test to prevent polymer housed surge arresters having improper design of the insulation [15]. Moisture ingress may result in moisture condensation, changing the protection level and the energy dissipation capability. Frequently, the surge arrester aging may present a gradual rising in the resistive component of the current loss that contributes to thermal instability and finally leads to complete fault (see Fig. 6).

Figure 6. Moisture ingress on the sealing interior [16].

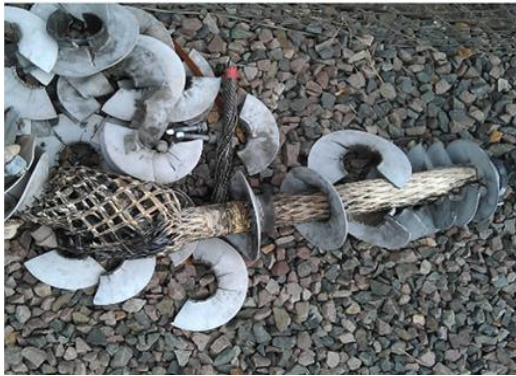
The arrester with polymer housing may burn open the external insulation; such failed arresters are shown in Fig. 7.

Figure 7. Metal oxide surge arresters with polymer housing that failed during in service condition.

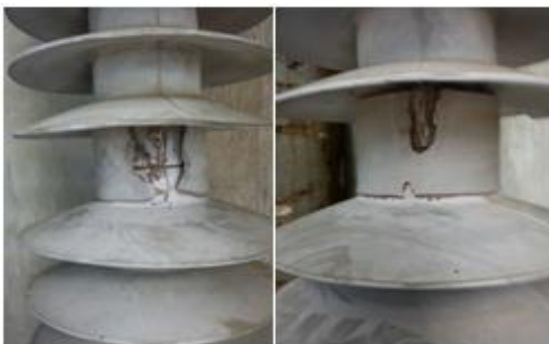
- Damage of sealing due to thermal heating produced inside varistor (see Fig. 8)

Figure 8. Defective sealing increase high rate of moisture ingress.

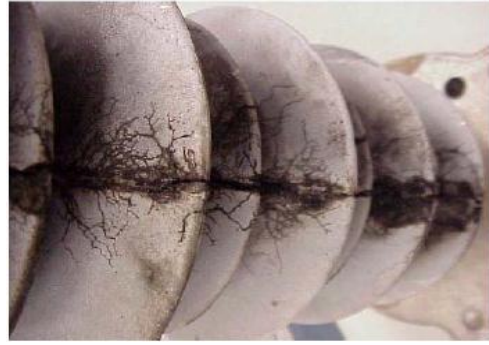
- Localized losses and discharges caused by poor inter-disc contact
- Housing deterioration or pollution changing the voltage distribution along the stack (see Fig. 9)

Figure 9. Deterioration on insulation housing [17].

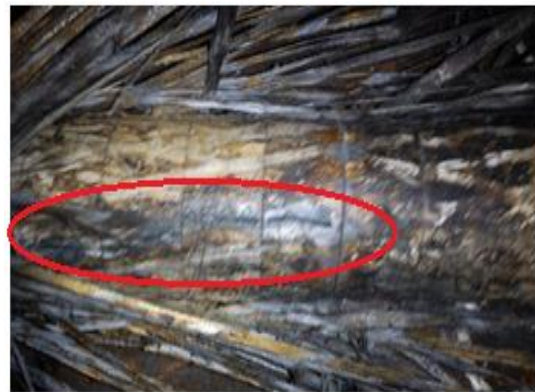
- Mechanical fractures in ZnO varistor due to thermal runaway after a high current surge (see Fig. 10)

Figure 10. Mechanical cracks in varistor elements.

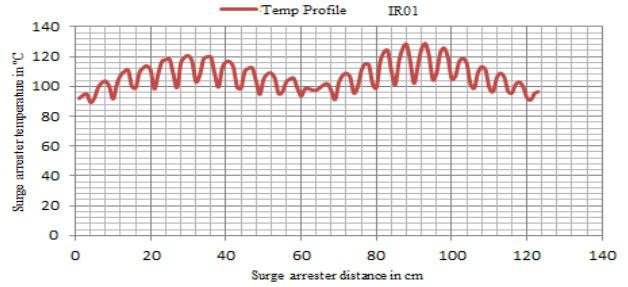
During the field trail analysis the results of failing arresters were obtained. Images of surge arresters showed the high rate of thermal heat. Results showed the thermal image and temperature profile of surge arresters tested, (see Fig. 12-Fig. 14). Note that the yellow in center of the image is a hot spot. This designates that instant de-energization and replacement must be undertaken before they failure.

Figure 12. Thermal image of arrester and temperature profile along the arrester.

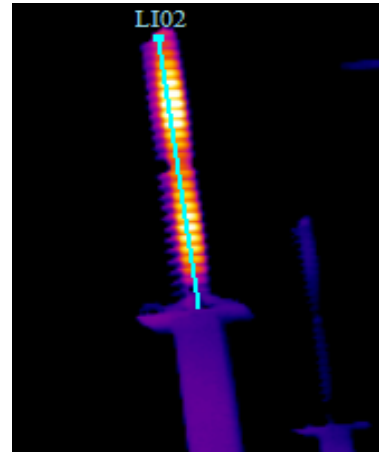
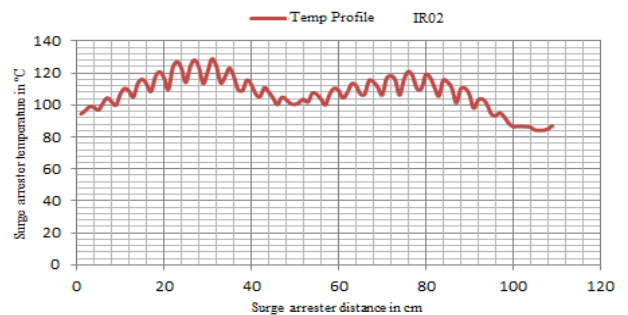
Figure 13. Thermal image of arrester and temperature profile along the arrester.

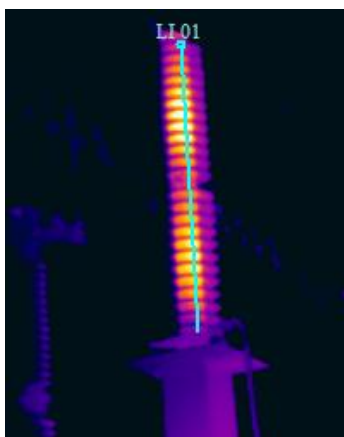
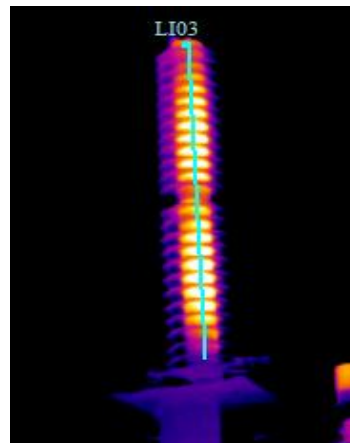
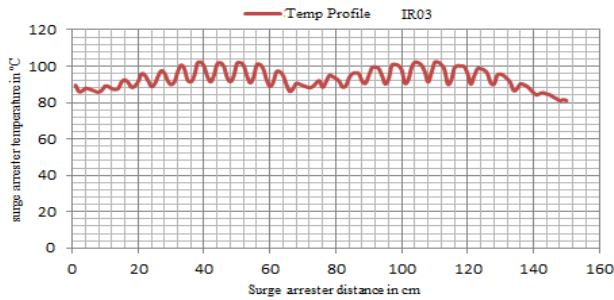
Figure 14. Thermal image of arrester and temperature profile along the arrester.

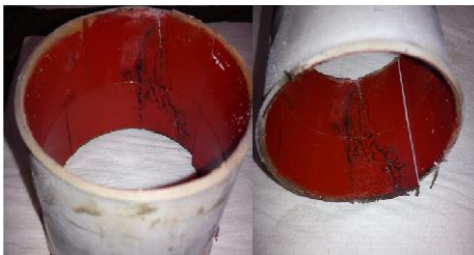
The results obtained during the visual inspection of the surge arresters of manufacturer A, (see Fig. 15-Fig. 18). The moisture ingress through the sealing collar causes serious problems such as surface discharges. These factors can eventually end with a full breakdown over the insulation system. Water treeing inside the sealing collar was noted as were cracks on the zinc oxide blocks closest to the sealing, this indicates that that the failing started here.

Figure 15. Treeing inside the sealing collar.

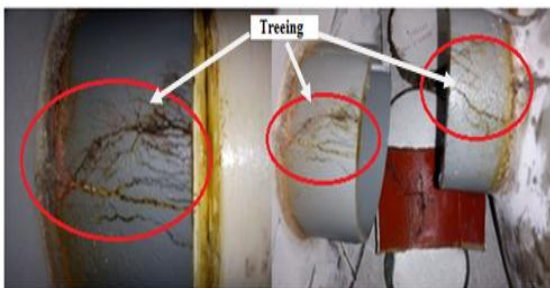
Figure 16. Water treeing on the sealing collar.

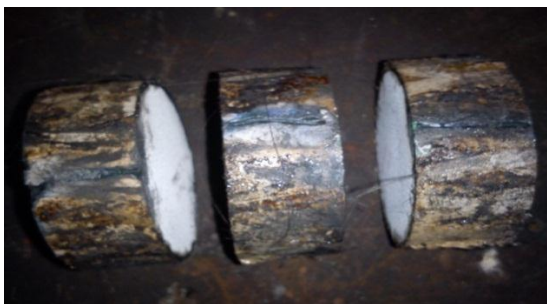
Figure 17. Cracks and damp on zinc oxide blocks.

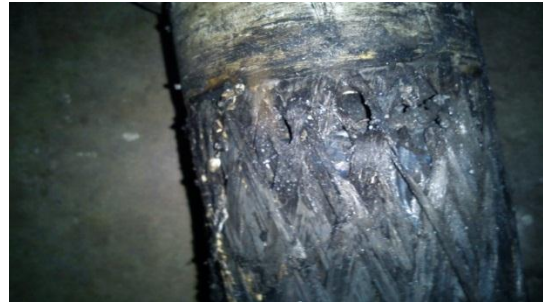
Figure 18. Damp on zinc oxide varistors.
