**INTERNATIONAL JOURNAL OF ENGINEERING SCIENCES & RESEARCH
TECHNOLOGY**

**INVESTIGATION INTO THE REASONS BEHIND PANEL FAILURE IN THE
DURBAN CONTAINER TERMINAL – PIER 2**

Rowen Naicker*, Dhiren Allopi

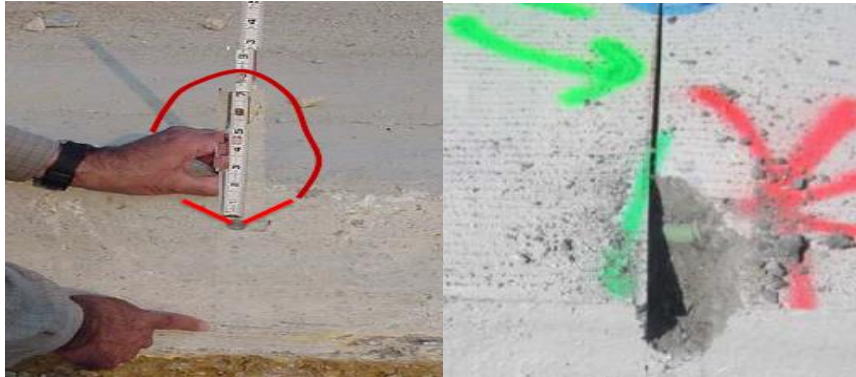
Figure 4: Bars placed at incorrect depths resulted in spalling (Khazanovich 2011: 45-46)

Dowel bars provide load transfer across joints which reduce stresses and deflections thereby reducing faulting at joints and slab cracking. However to ensure proper functioning of the dowels, proper placement is critical. The above figure (figure 4) displays an example of a dowel bar that was placed incorrectly, which resulted in spalling, due to insufficient cover.

- Dowel and tie bars should be placed mid-depth of the slab.
- When installing dowel and tie bars loose concrete should be removed from the concrete face.
- A bond breaking compound should be applied to the face of the concrete and on one half of the dowel bar (the half that does not have epoxy applied).
- Dowel bars are generally placed transversely and tie bars longitudinally.
- When placing dowel and tie bars ensure that there is sufficient spacing between the bars to avoid clashing.
- To avoid poor joint performance and inadequate load transfer, dowel and tie bars should be placed at 90° to the face of the concrete.

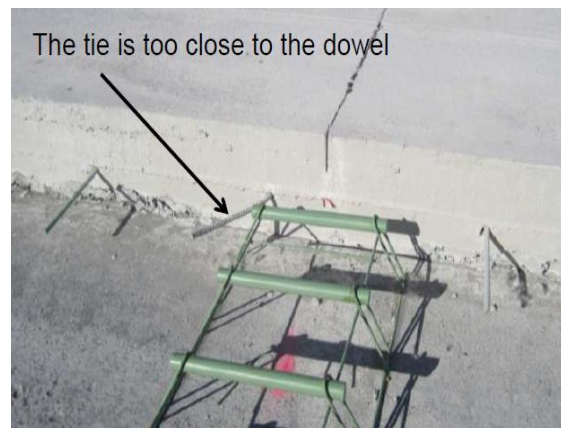
Clashing of the bars will result in spalling and cracking. The tie bar pointed out in Figure 5 will not be effective in preventing lane separation and deflections due to clashing of the bars. This will ultimately lead to panel failure.

Figure 5: Clashing of bars (Khazanovich 2011: 49)

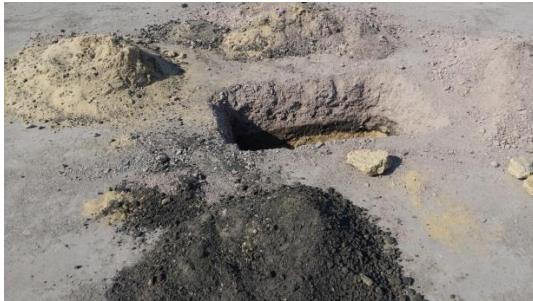
Fly ash is inconsistent in terms of thickness and quality and is therefore not graded or classified as G6, 7, 8 or 9. Sometimes you do get decent material but it is very fine and cannot be compacted (similar to cake flour). Concrete pavements rely on the layers below for support, so imagine a sheet of glass on mattress vs it being on a table. The concrete can withstand a certain amount of flexure as it is unreinforced, but as soon as we have “soft spots” then we get differential settlements which results in premature failure. There were serious panel failures in the areas that contained fly ash material in Pier 2.

Figure 6: trial pits

Firstly trial pits were excavated (figure 6) and samples were taken to the laboratory to test and confirm that the contaminated material was actually fly ash. Thereafter, all the fly ash material was cut and spoiled (figure 7) and replaced with G5 and G2 up to the underside of the slab. The depth of the fly ash material went as far as 1 meter deep (figure 8).

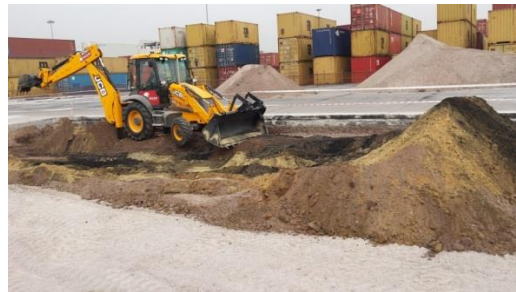
Figure 7: contaminated material

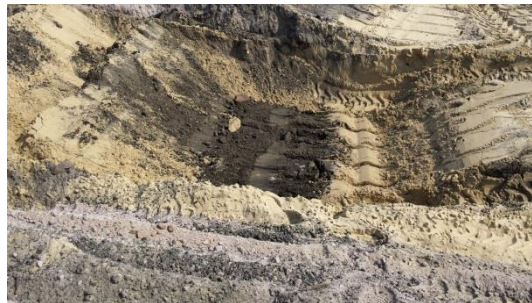
Figure 8: flyash approx 1 meter deep

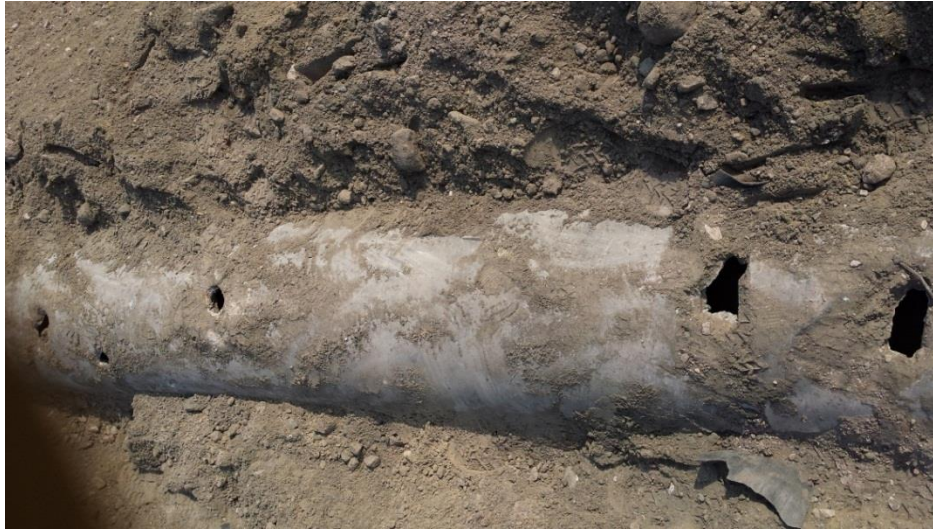
Damaged stormwater pipes were one of the common problems that contributed towards panel failure at DCT. Due to the loss of sand through various cracks on the pipe (Figure 9) , the layer works above the stormwater pipe destabilized which eventually resulted in panel failure. Figure 10 and 11 depicts the collar of a stormwater pipe being repaired after it was discovered to be broken.

Figure 9: damaged stormwater pipe

Due to the flooding of excavations because of high tides (Figure 10), a quick and effective solution had to be implemented when excavating down to the damaged stormwater pipe. As a quick solution, it is recommended that bidim be wrapped around the vicinity of the collar and secured with binding wire (Figure 11).

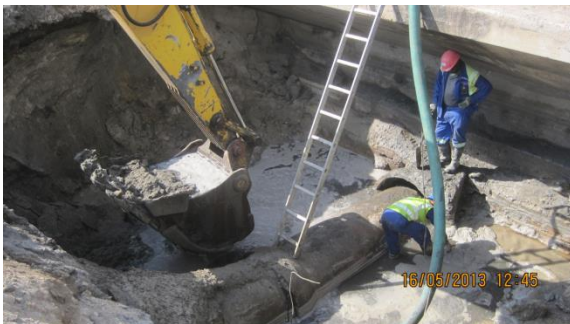
Figure 10: working against the tide

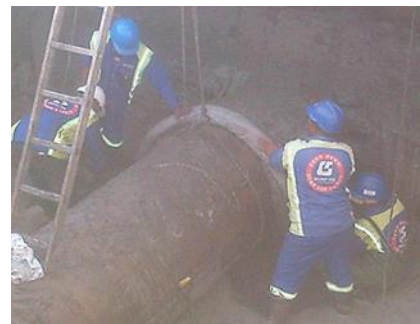
Figure 11: wrapping bidim around the pipe

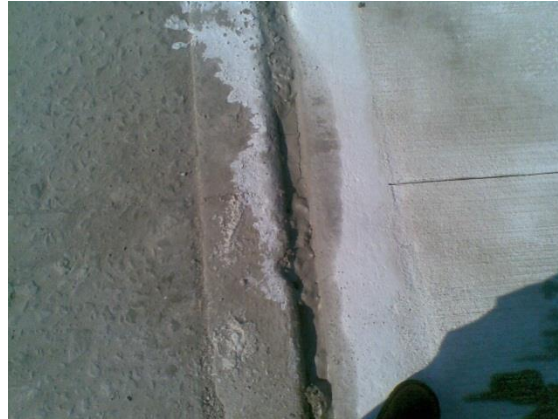
Slot drain cleaning plays a pivotal role in ensuring concrete panels maintain the life expectancy period and must be practiced on an ongoing basis. When slot drains are blocked (figure 12), water will pond on the surface of the concrete and will eventually seep in joints where the sealing has been omitted or has become old and needs to be replaced. Thereafter the water will begin to undermine the slab by weakening the layerworks underneath which will eventually lead to a panel failure.

Figure 12: blocked slot drain

- After a slot drain is cleaned a team should return to that slot drain at least every 3 months due to the fact that oil and grease will always block the drain.
- Slot drain cleaning should be practiced on an ongoing basis and a full time drain cleaning team should be employed to carry out this task.
- The correct procedure to clean a slot drain is to firstly remove debris using a tool called a spoon (Fig13 & 14) and thereafter perform hydro-jet cleaning to the drain.

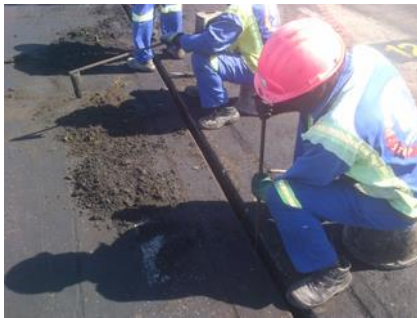
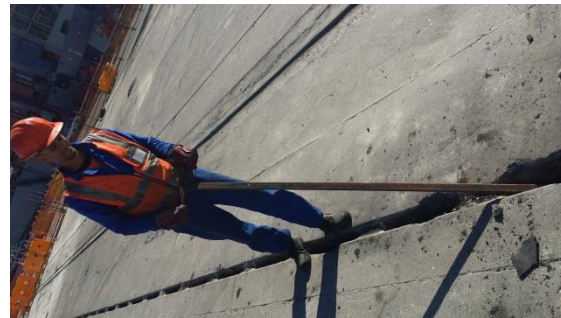
Figure 13: spooning

Figure 14: spooning

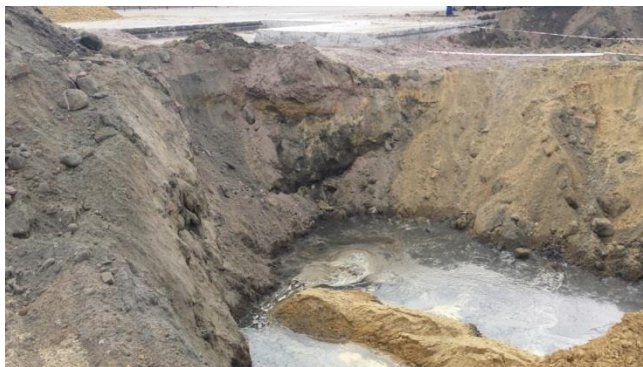
It was noticed that unfitting backfill material (figure 15) was used in some areas in Pier 2. This resulted in hard and soft spots (figure 16) being formed in the vicinity in which there were vast amounts of panel failure. Serious panel failure resulted due to the fact that this material lacked compaction and subgrade uniformity.

Figure 15: Rubble used as backfill

The unsuitable material should be removed and replaced with imported G10 and thereafter be completed with 150mm of G5 and G2 up to the underside of the slab. After compaction of each of these layers density tests should be carried out progressively. Density tests should be done at least every 300mm on the G10 depending on the depth of the backfill.

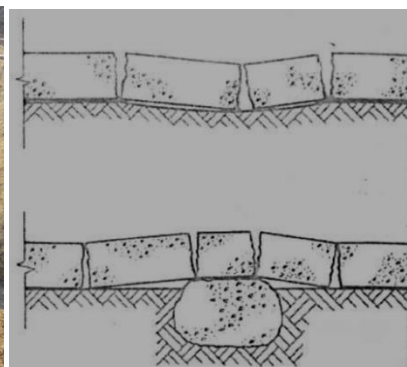
Figure 16: Hard and soft spots

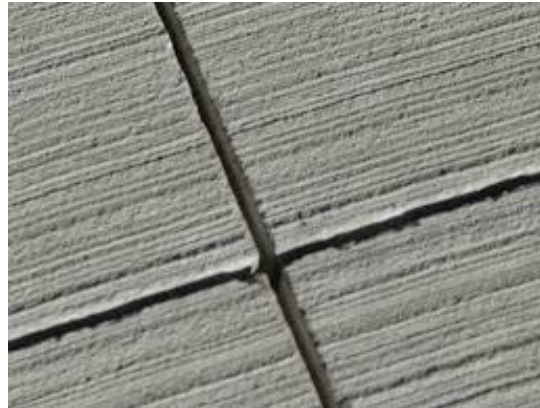
Figure 17: absence of joint sealing

One of the causes of panel failure is the lack of maintenance of joints. When water ponds on panels due to insufficient surface runoff or slot drain blockages, it eventually seeps through joints if the joint sealing is worn, omitted or sealed using improper techniques. Eventually the water will then undermine the slab by weakening the subgrade and will ultimately lead to panel failure.

- Joints should be inspected on a regular basis and sealed when required.
- After sealing it is recommended that a pull out test be carried out.

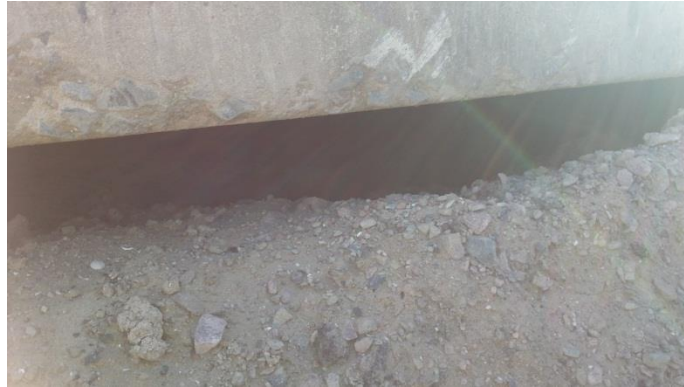
There was an increase in panel failure along the quay wall. An investigation was carried out and it was discovered that the existing marine sand was seeping through the joint of the quay wall during high tides. Failure of the road and concrete panels resulted from the destabilization of the layerworks, which occurred over a protracted period (Figure 18)

Figure 18: destabilization of the layerworks

Fix bitum on the joint as a quick yet effective solution due to the flooding of excavations because of high tides. Water pumps had to be used whilst repairing the quay wall to reduce the accumulation of water during high tides (Figure 19)

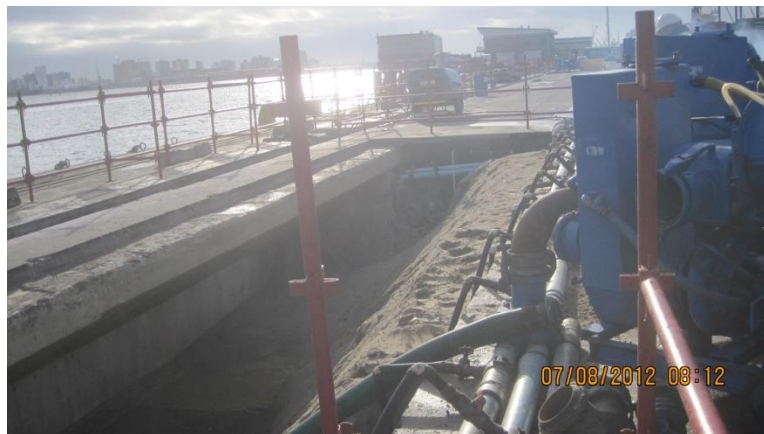
Figure 19: water pumps used
