Surge Arrester Faults and Their Causes at EThekwini Electricity

M. Gumede and G. Frederick d’Almaine

Durban University of Technology/Power Engineering, Durban, South Africa

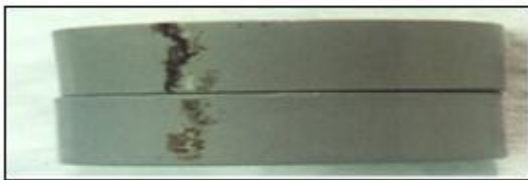
As discussed earlier, moisture or humidity inside surge arresters plays a significant role in the degradation process of varistor elements. This moisture increases thermal heating, leakage current [8] and causes discharges. These phenomena are directly responsible for tracking and erosion in a ZnO varistor block of an arrester (see Fig. 3).

Figure 3. Internal partial discharge [10].
